# DEVELOPMENT OF HIGH-SPEED BALANCING TECHNOLOGY

R. DeMuth and Dr. E. Zorzi

**MECHANICAL TECHNOLOGY INCORPORATED**

NASA Lewis Research Center  
Contract NAS 3-18520  
David P. Fleming, Project Manager

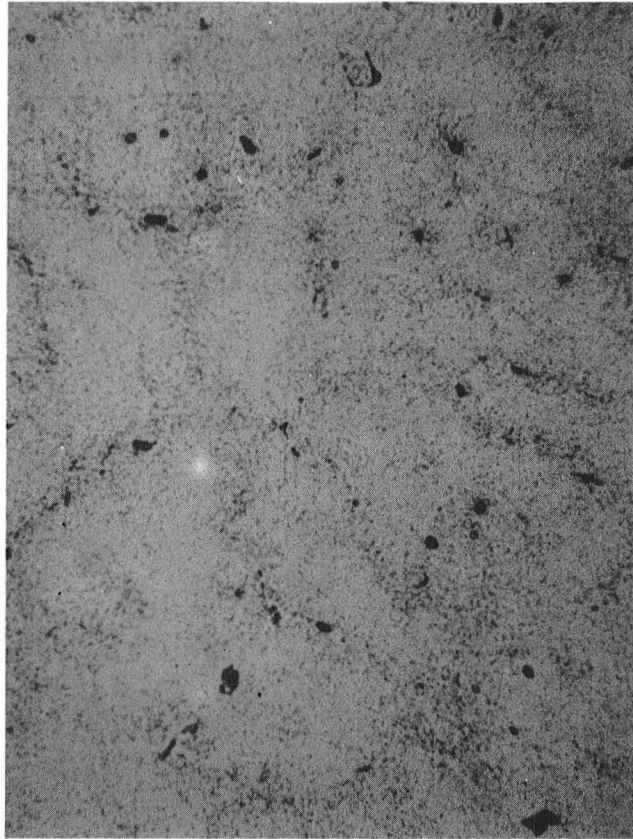
Figure 27 Bulk Microstructure of 6061-T6 Aluminum  
(From Longitudinal Cross-Section Specimen  
of Laser Burn - Mg<sub>2</sub>Si Particles (Black) and  
Fe<sub>3</sub>SiAl<sub>12</sub> Precipitates (Grey Dots) in a  
Matrix of Aluminum Solid Solution)

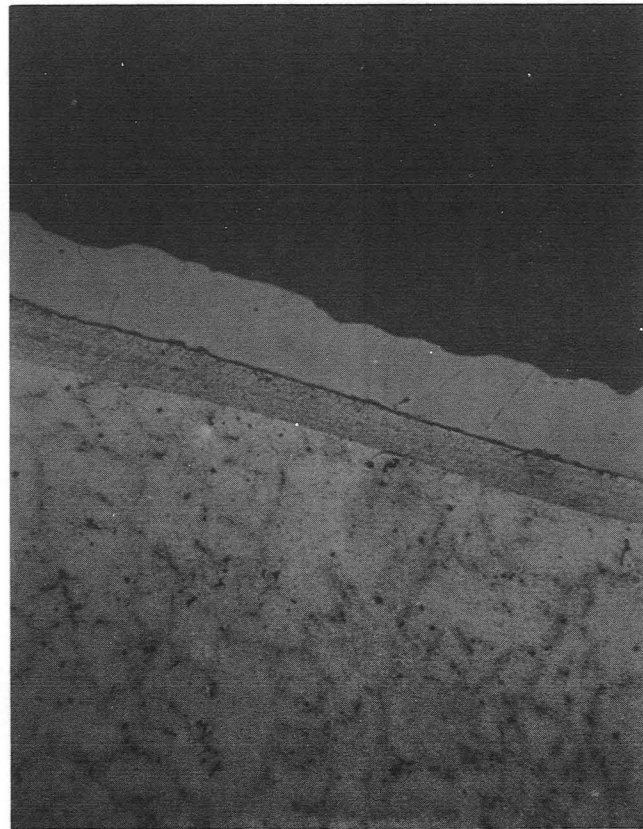
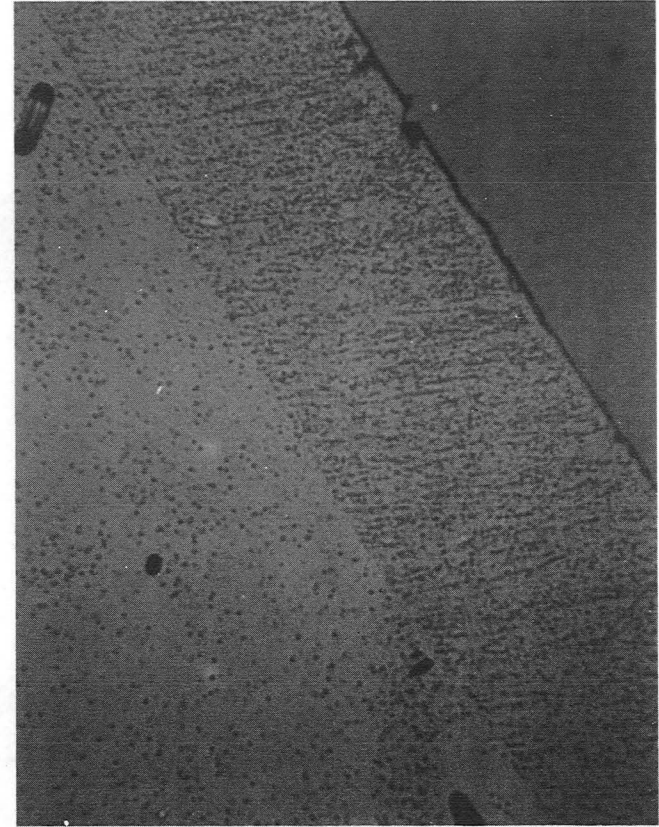
A. Magnification at 125X (L1273)

B. Magnification at 1000X (L1277)

Figure 28 Microstructure of the Laser-Affected Zone in 6061-T6 Aluminum (at the One-Quarter Distance Point Along Laser Burn) Directionally Segregated  $\text{FeSiAl}_2$  Precipitates in Matrix of Cast Aluminum Solid Solution

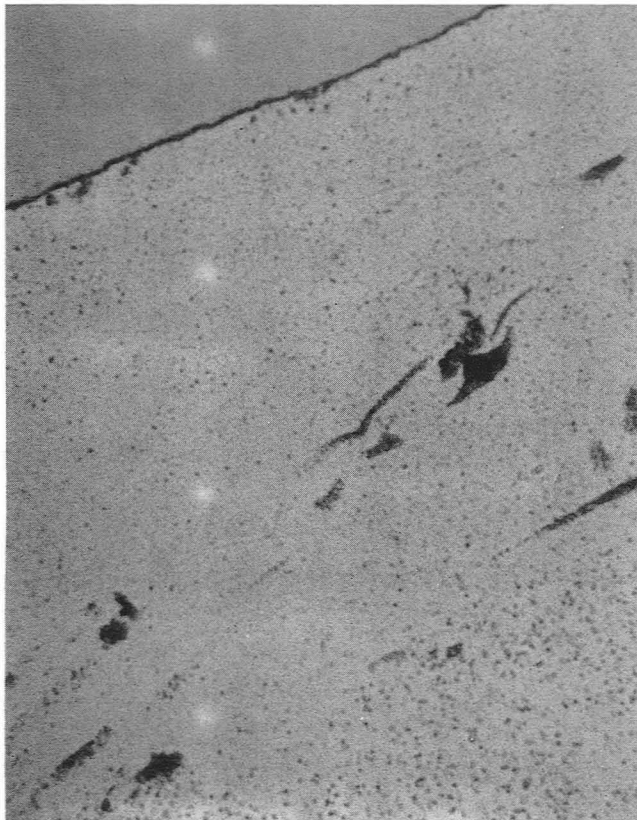
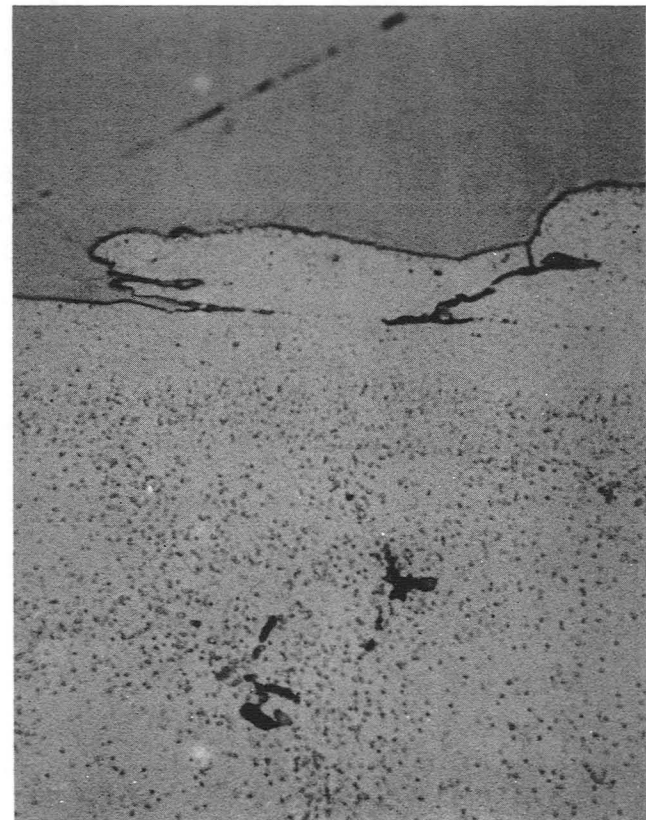
A. Near End of Laser Burn at 1000 X (L1279)

B. Near End of Laser Burn at 1000X (L1278)

Figure 29 Microstructure of the Laser-Affected Zone in 6061-T6 Aluminum  
 $\text{FeSiAl}_{12}$  Precipitates in a Cast Aluminum Solid Solution Matrix

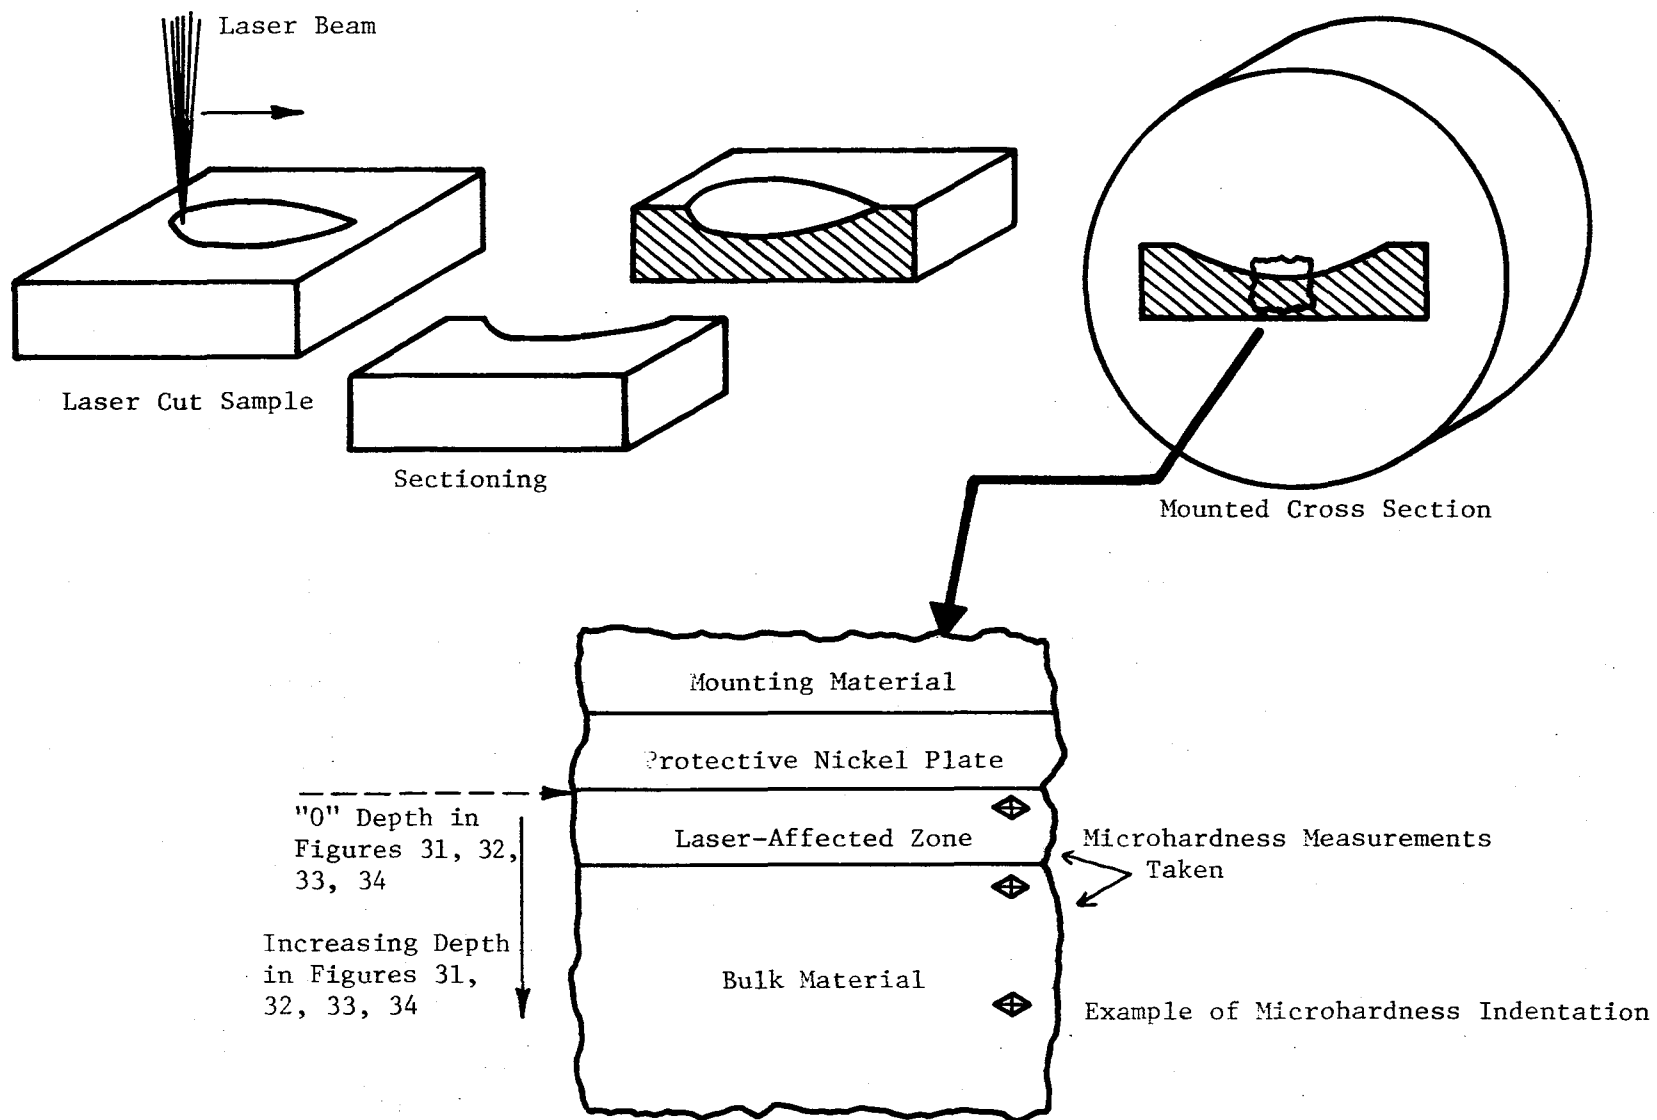
Figure 30 Sketches of Laser Cut Sample: Sectioning, Mounting and Microhardness Measurements

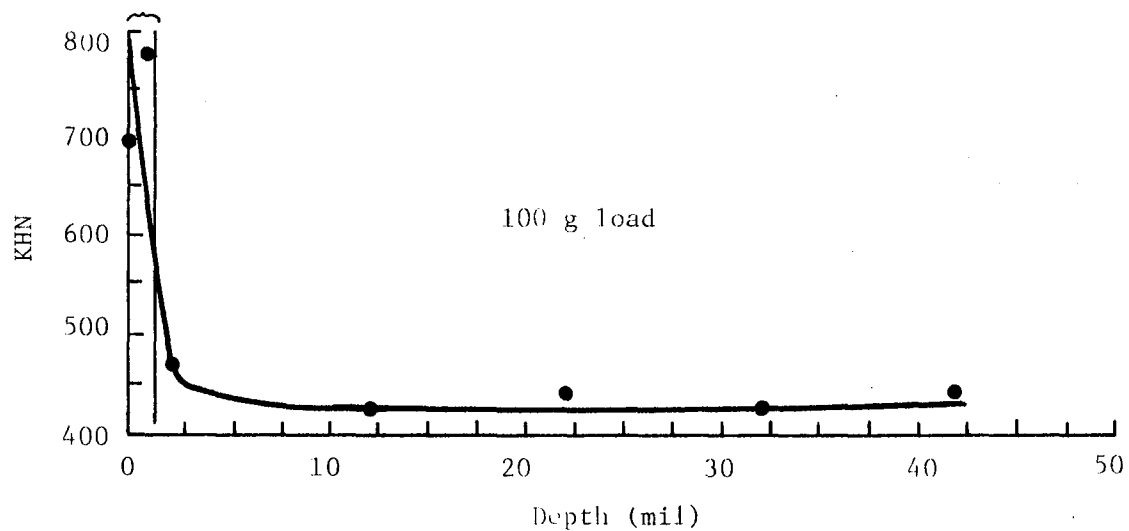
Laser-Affected Zone ( $\sim 32 \mu\text{m}$ ) 1.26 mil (determined microscopically)

Figure 31 Microhardness - Depth Profile: 4340

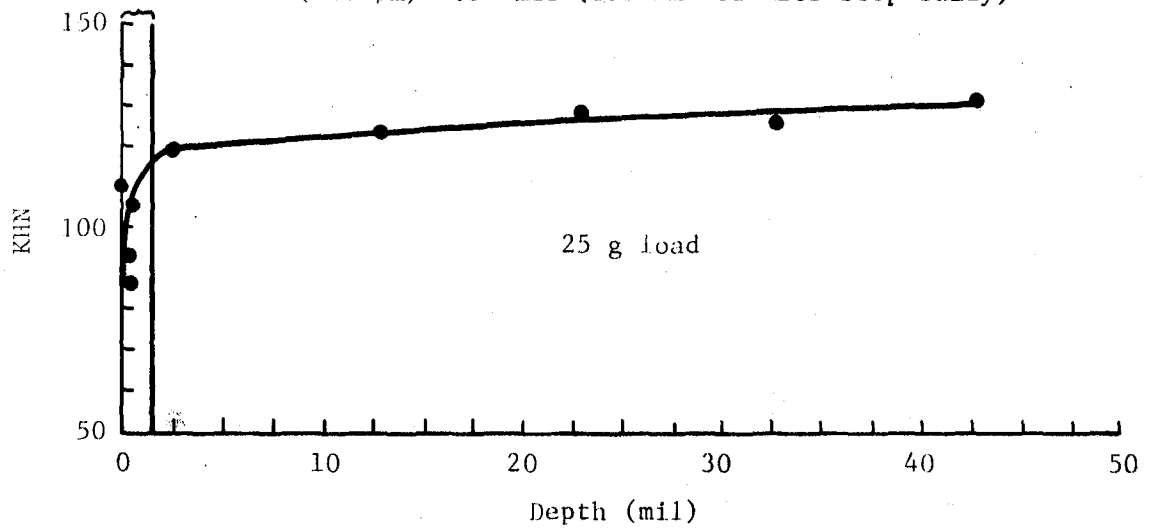
Laser-Affected Zone ( $\sim 40 \mu\text{m}$ ) 1.57 mil (determined microscopically)

Figure 32 Microhardness - Depth Profile: 6061-T6

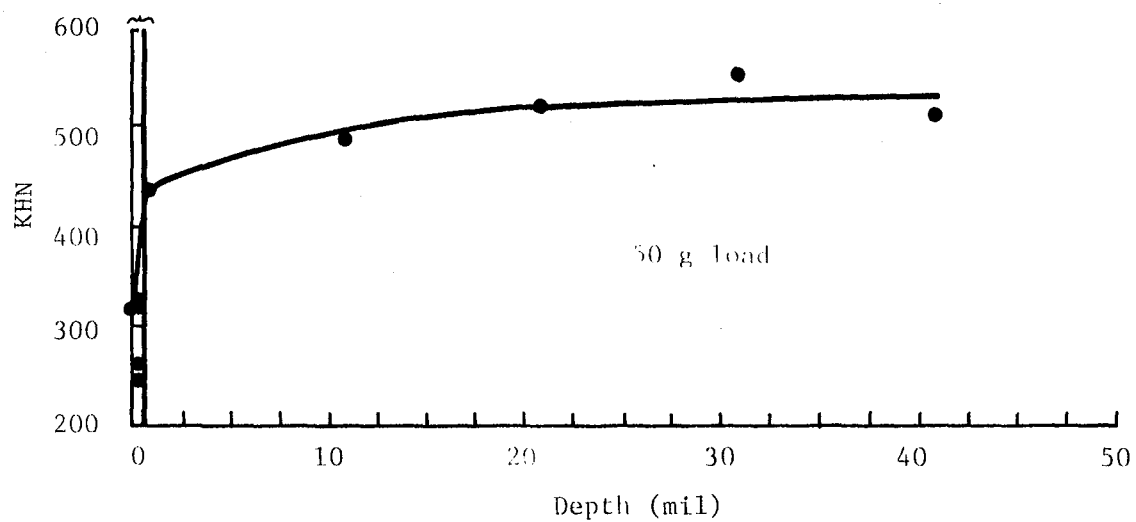
Laser-Affected Zone ( $\sim 18 \mu\text{m}$ ) 0.71 mil (determined microscopically)

Figure 33 Microhardness - Depth Profile: 17-4 PH

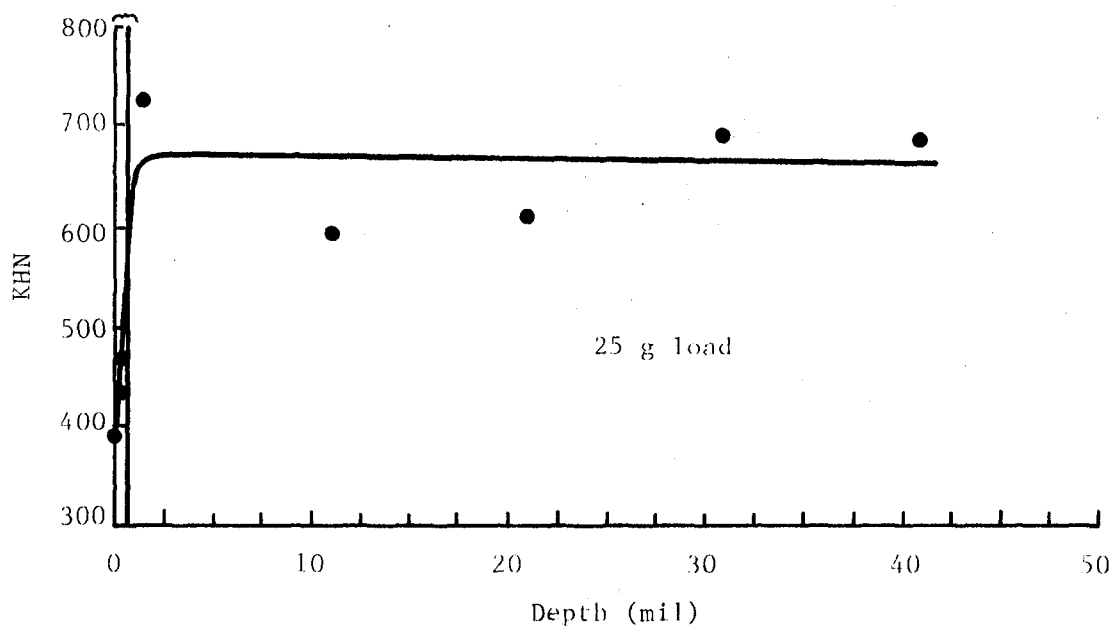
Laser-Affected Zone ( $\approx 18 \mu\text{m}$ ) 0.71 mil (determined microscopically)

Figure 34 Microhardness - Depth Profile: Inconel 718

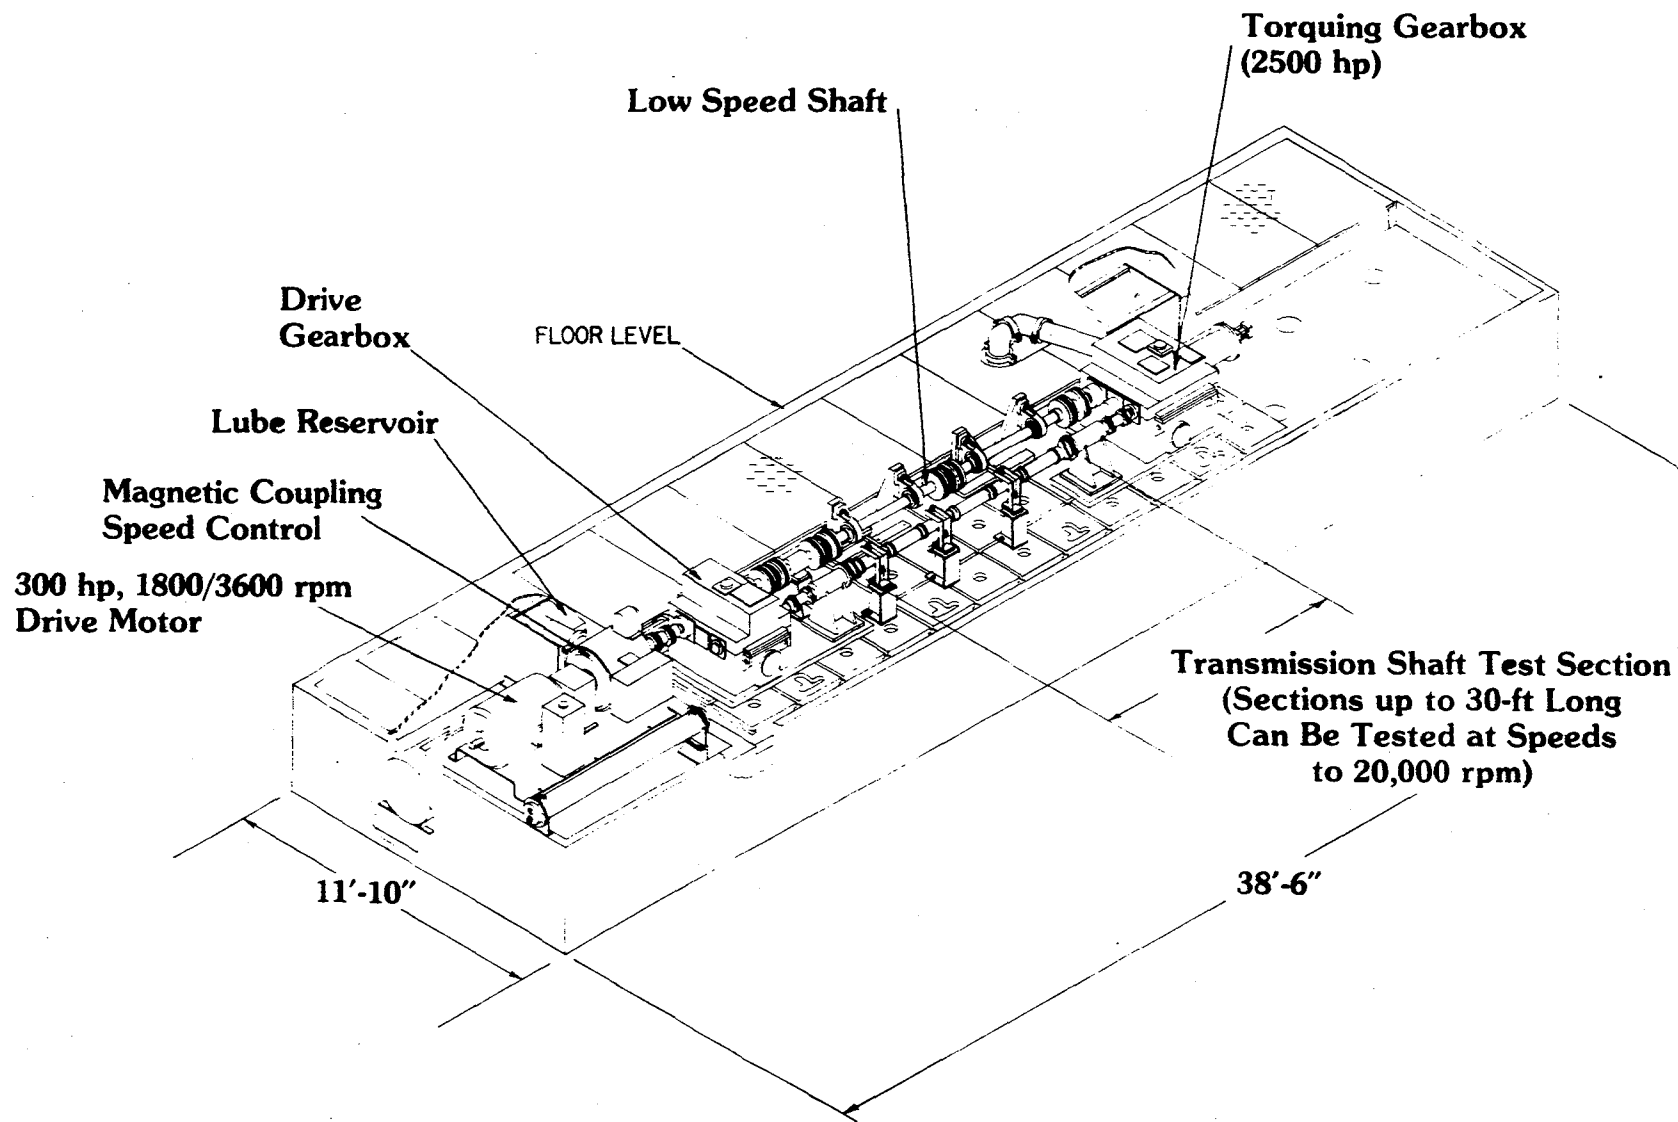
Figure 35 Drive Train Dynamics Technology Test Rig Configuration for High-Speed Shaft Balancing

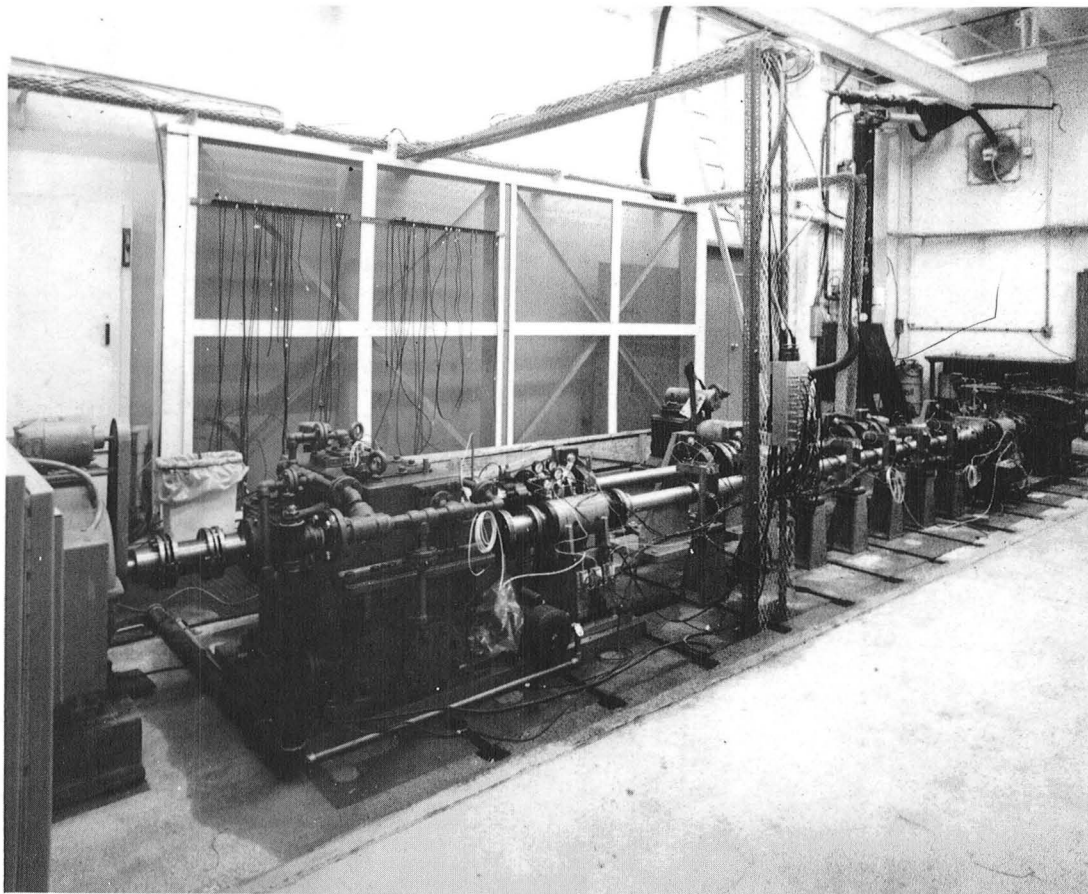
Figure 36 . View of Completely Assembled Test Rig Showing  
High-Speed Side from Drive Gearbox End

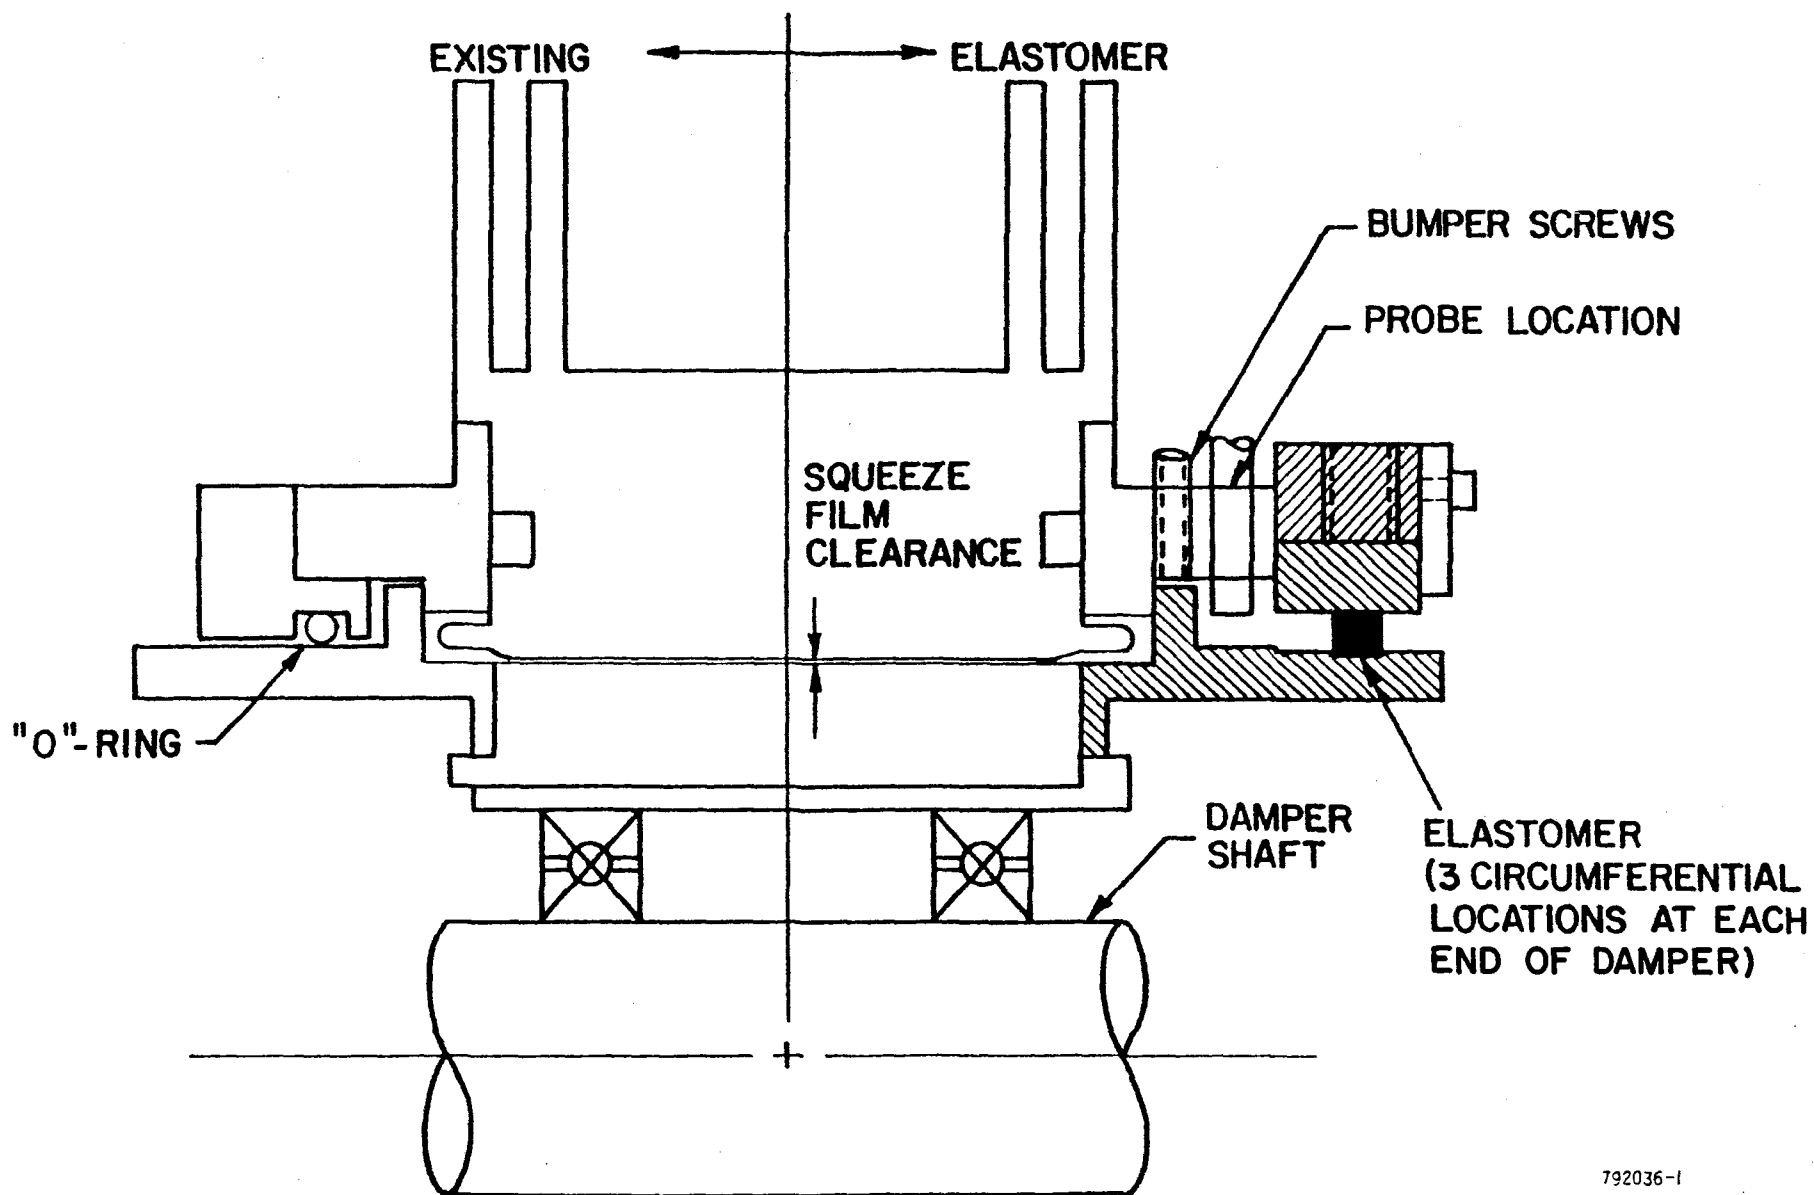
Figure 37 Elastomer Damper/Squeeze-Film Damper Schematic

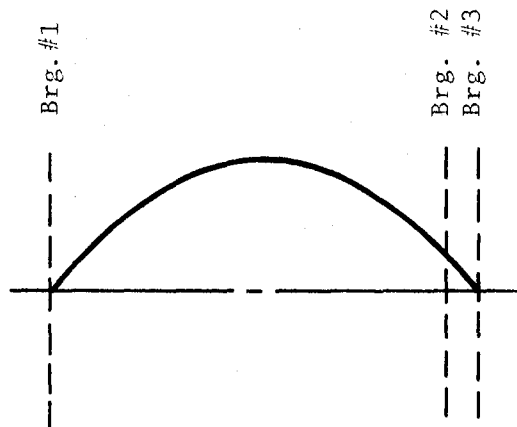
Figure 38 First Rotor Critical Speed Mode Shape

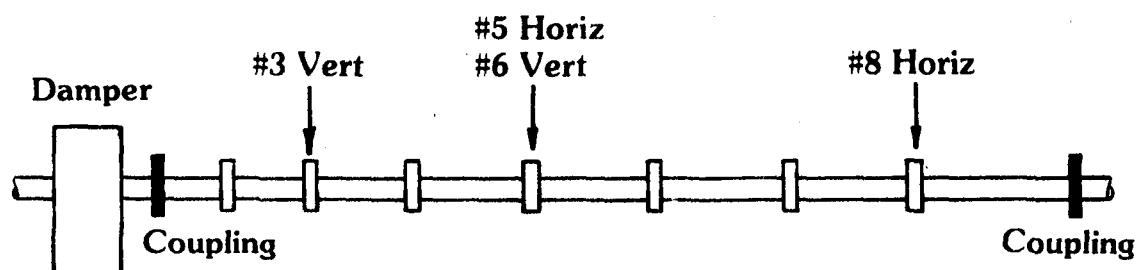
Figure 39 Rig Configuration with Instrumentation

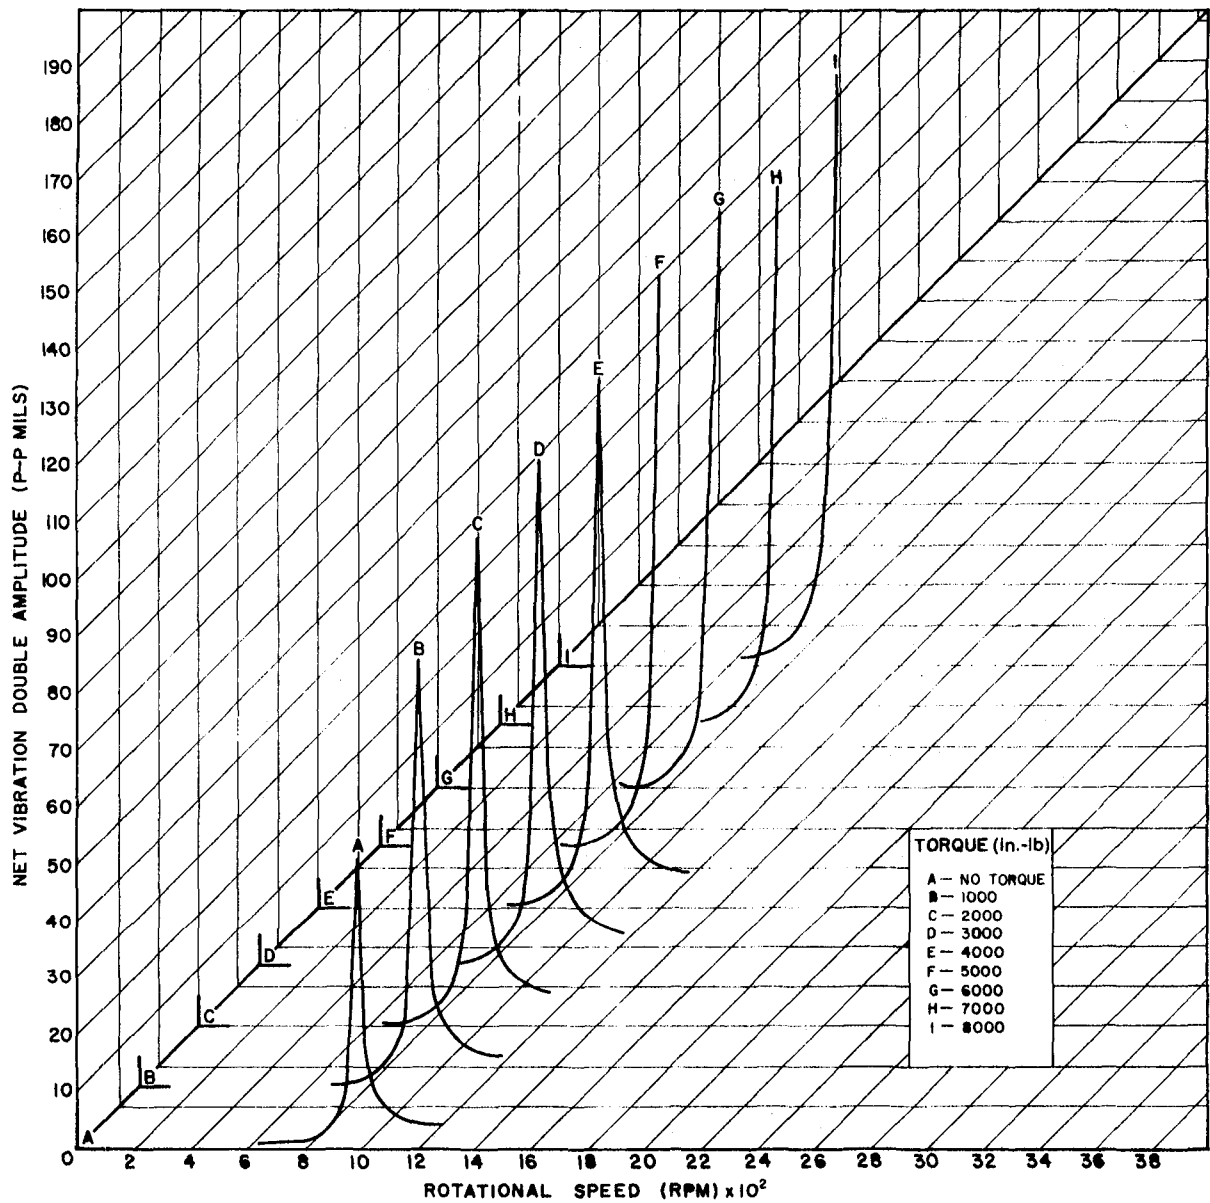
Figure 40 Baseline Test Condition - Probe 6  
(balanced without torque)

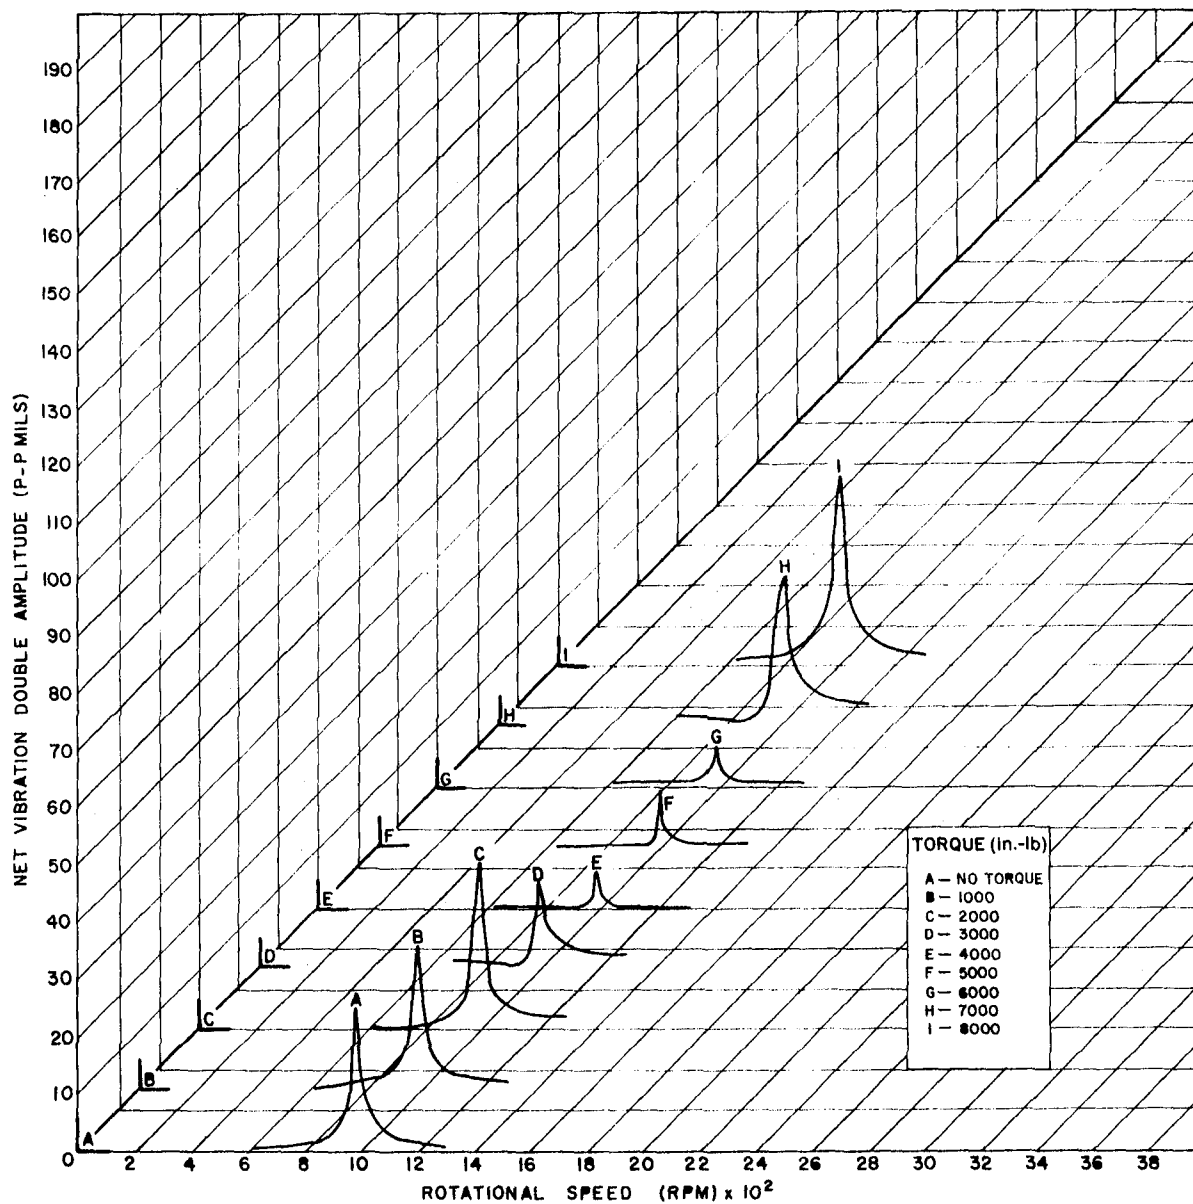
Figure 41 Rotor Response After Balancing Correction Applied for Torque Condition - Probe 8

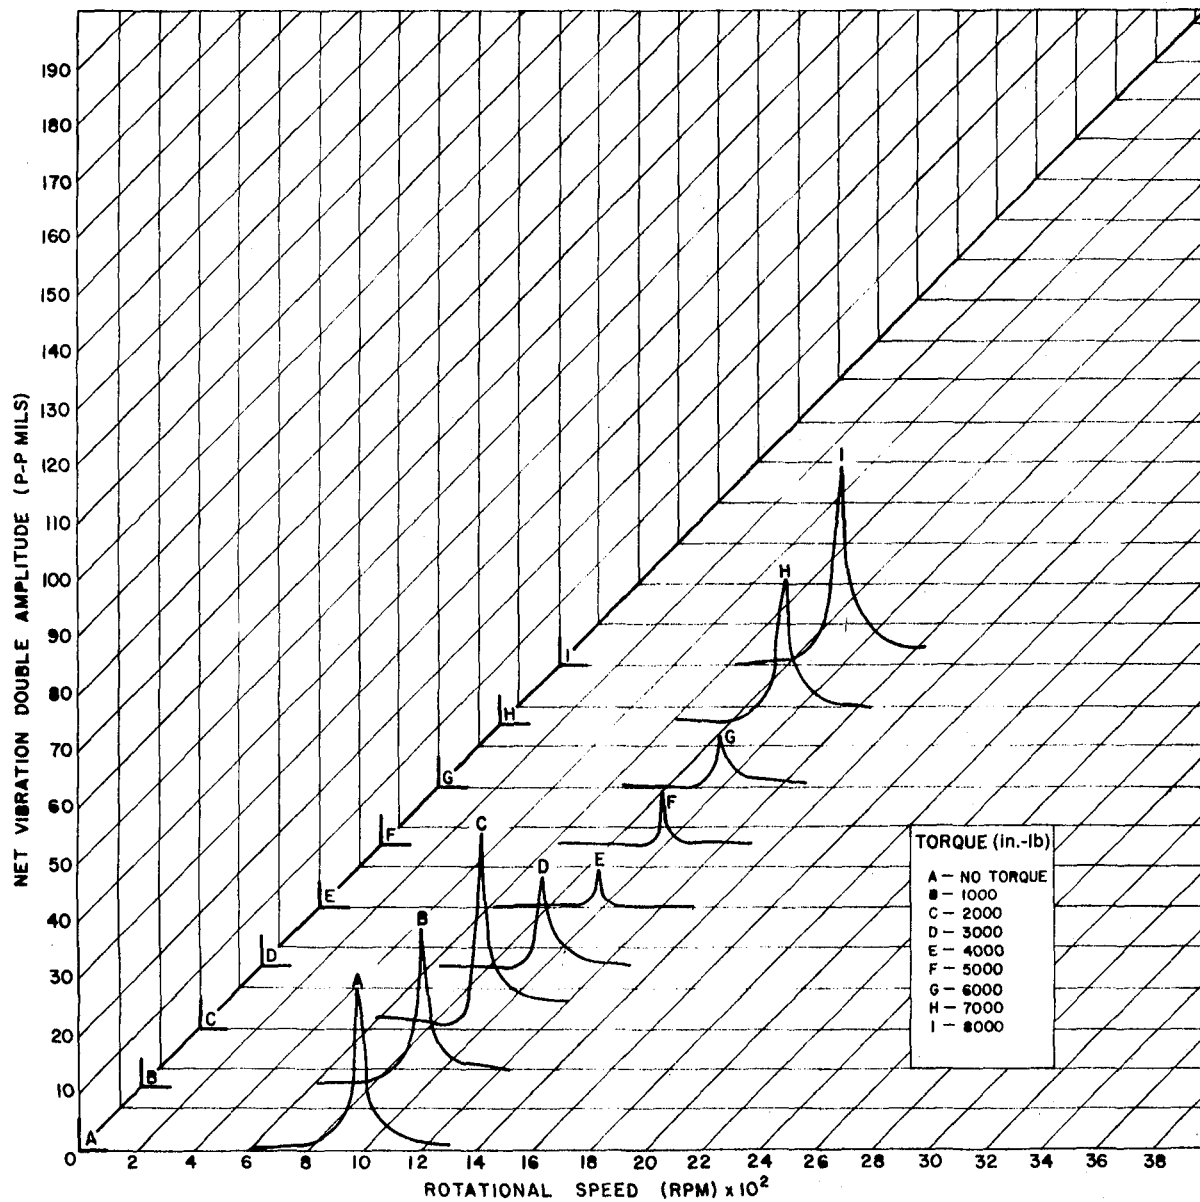
Figure 42 Rotor Response After Balancing Correction Applied for Torque Condition - Probe 3

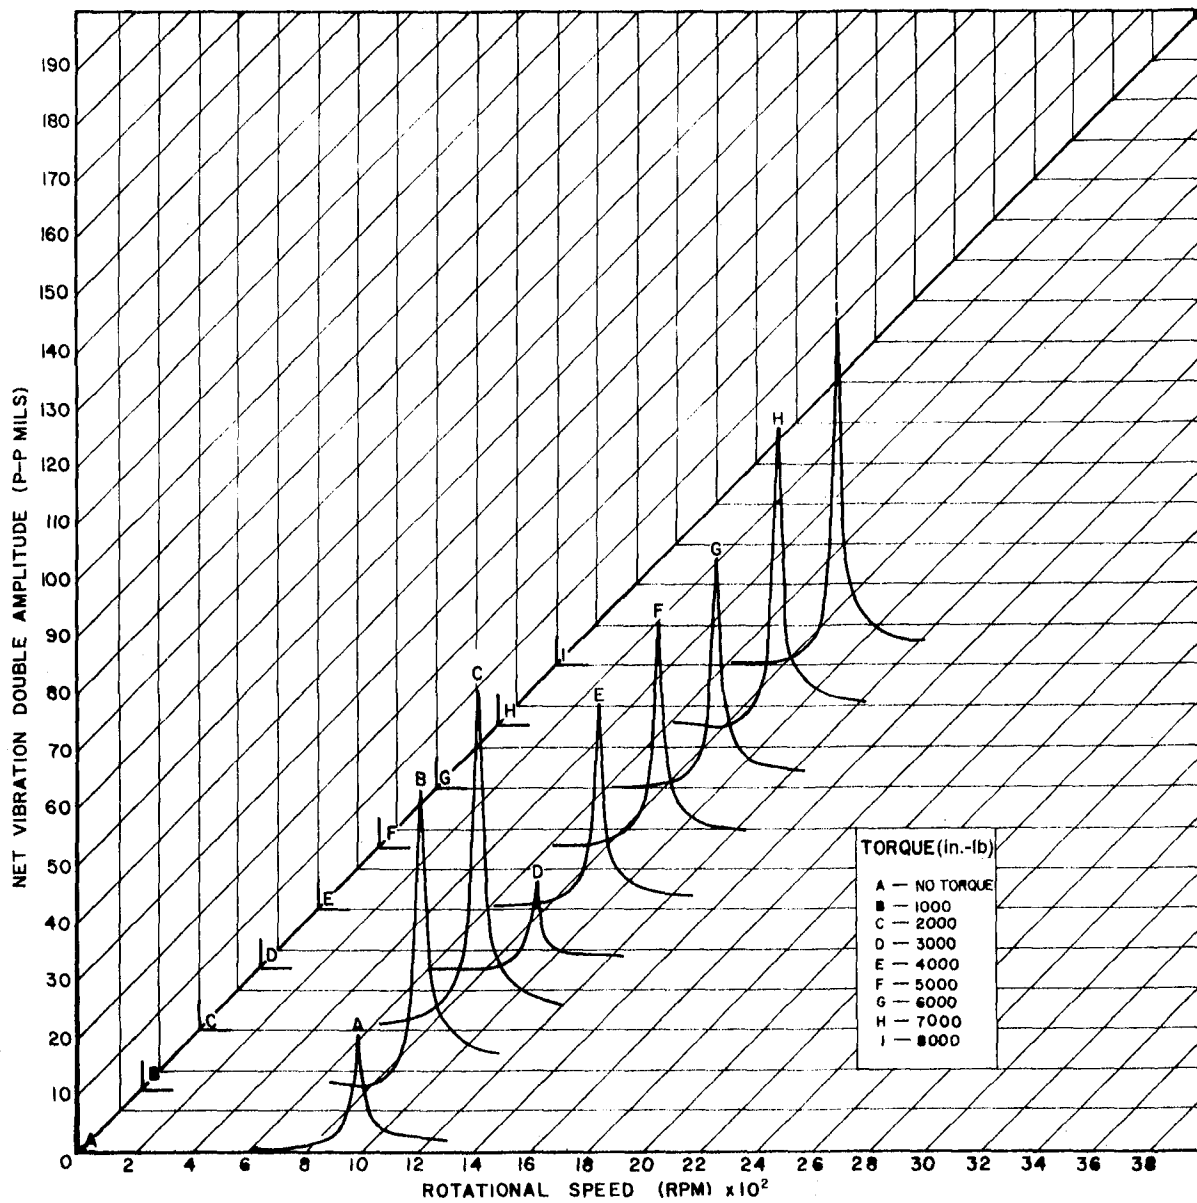
Figure 43 Rotor Response After Balancing Correction Applied for Torque - Probe 5

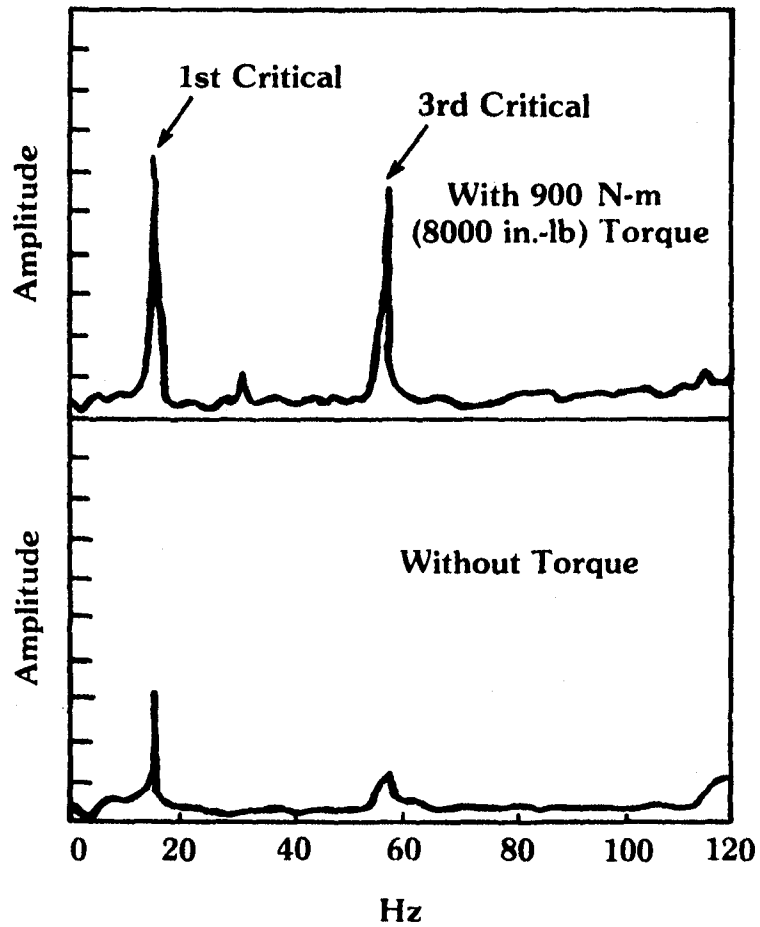
Figure 44 Typical Synchronous Response of Power Transmission Shaft With and Without Torque Loading
